# NATIONAL TRANSPORTATION SAFETY BOARD

## AIRCRAFT ACCIDENT REPORT

EASTERN AIR LINES, INC.,  
LOCKHEED L-1011, N334EA  
MIAMI INTERNATIONAL AIRPORT  
MIAMI, FLORIDA  
MAY 5, 1983

NTSB/AAR-84/04

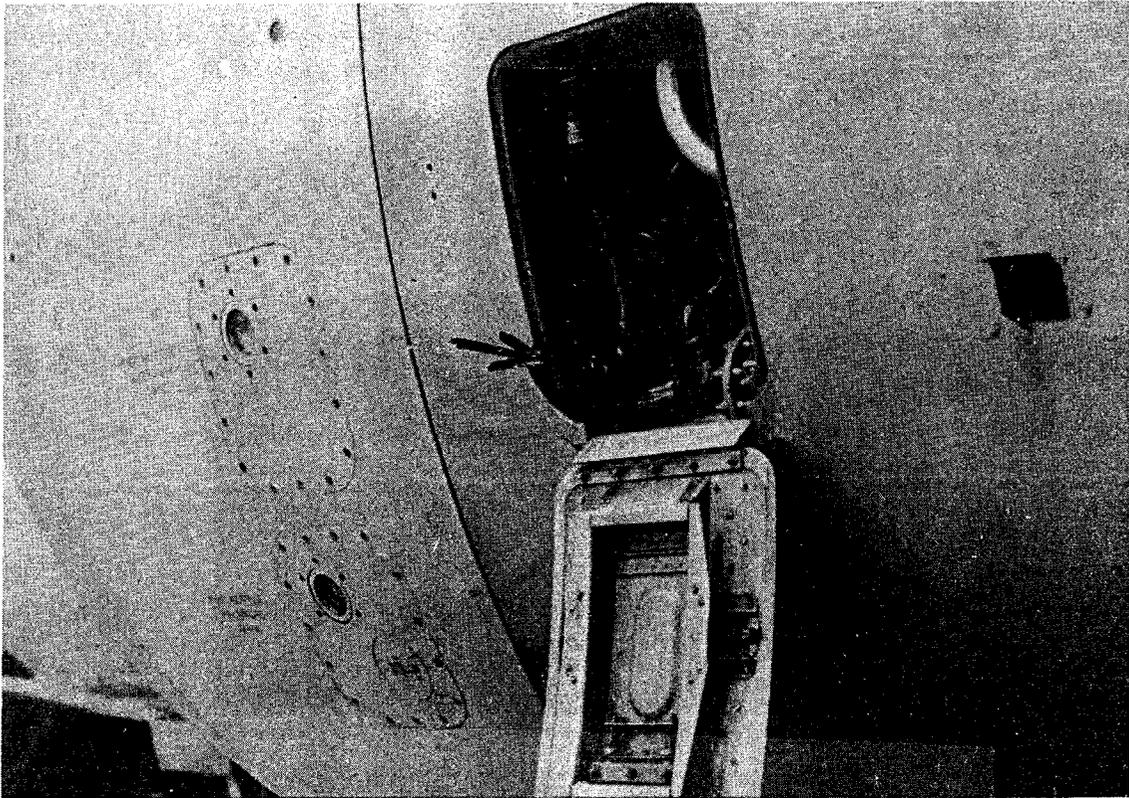
Figure 4.—Oil service door and chip detector location, engine No. 1.

He first went to engine No. 1, and he had to place his hand inside the oil service door 4 to 6 inches to reach the detector. He then removed the master chip detector from the engine. (See figure 5.) He stated that he could not simultaneously place his hand on the master chip detector and look at the detector, so he usually removed and replaced master chip detectors by feel. The mechanic said that he did not examine the replacement magnetic chip detectors to insure that the O-ring seals were installed. He said he had assumed that they were installed because the sealed plastic package had a serviceable parts tag, and because previous master chip detectors he had installed always had had O-ring seals installed. He inserted the replacement master chip detector in the No. 1 engine and then proceeded to the No. 3 engine where he repeated the procedure. He stated that he could not feel any difference between a master chip detector with O-ring seals and one without O-ring seals once the detector was installed in the engine. He then waited for the other mechanic to replace the master chip detector on the No. 2 engine.

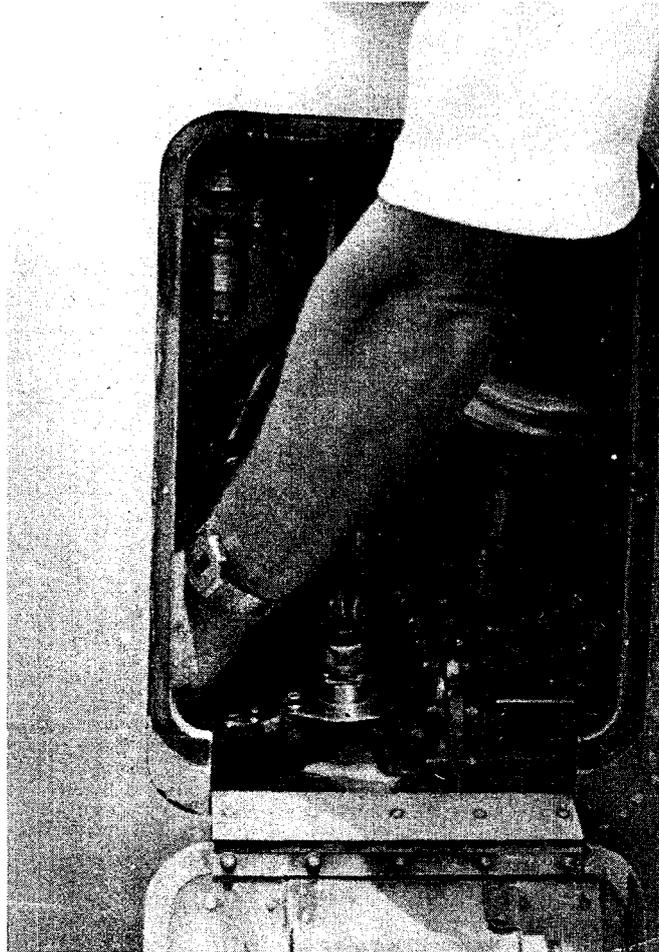
Figure 5.—Mechanic's access to chip detector.

The mechanic used a lift truck which had been positioned by the airplane to lift himself up to the No. 2 engine. He opened the oil service door and went into the engine (see figure 6). A light was located inside the engine cowling; however, a flashlight was required to see the engine parts clearly. The master chip detector was located directly over his head, so with one hand he removed the old master chip detector and with a rag in his other hand he reached up to catch the dripping oil. He then installed the new detector which he had placed on a ledge in the cowling. The old detector, which had been

removed, was put in the plastic package. He did not inspect the replacement master chip detector for O-ring seals, even though he said it was his responsibility to insure that the master chip detector was configured properly before he inserted it in the engine.
